Tested Independently: Quality You Can Trust

54501-25000 HYUNDAI ACCENT (1999-2006)

4764500AC CHRYSLER SEBRING (1996-2006)

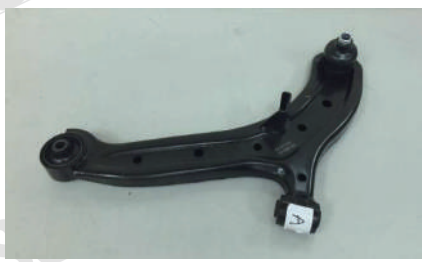
Photo A: Appearance of the sample A

Others

With less than 70% load, the competitor sample begins to fail. The base was deformed and testing was terminated.

Sample	Weigh (kg)	Max. force (kgf)	Result
A (OTHERS)	3.09	3374.6	The universal joint wasn’t pulled out from the base, but the base was deformed.
B (NAKAMOTO)	2.89	5000.0	The universal joint wasn’t pulled out from the base.
C (OE)	2.96	5000.0	The universal joint wasn’t pulled out from the base.

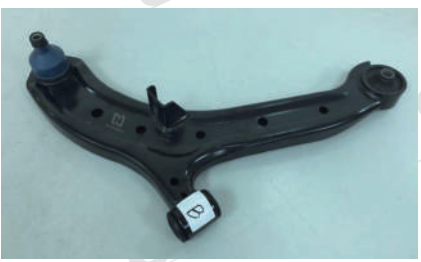
Photo B: Appearance of the sample B

NAKAMOTO®

Benchmarked against the OE product, the NAKAMOTO control arm sustained the maximum pressure of 5,000 Kgs without any sign of damage. A testament to the quality of our products and guaranteeing the safety of our customers.

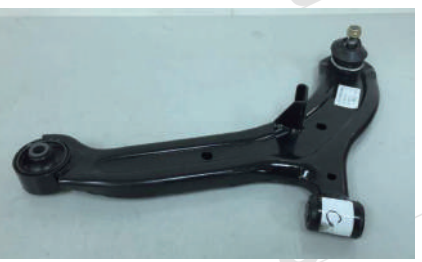
Photo C: Appearance of the sample C

OE
