RUBBER PARTS D04

C.V. BOOTS & STEERING BOOTS

- SUPERIOR DESIGN & MATERIALS
- STAINLESS STEEL 430 CLAMP
- WHY IT MATTERS?

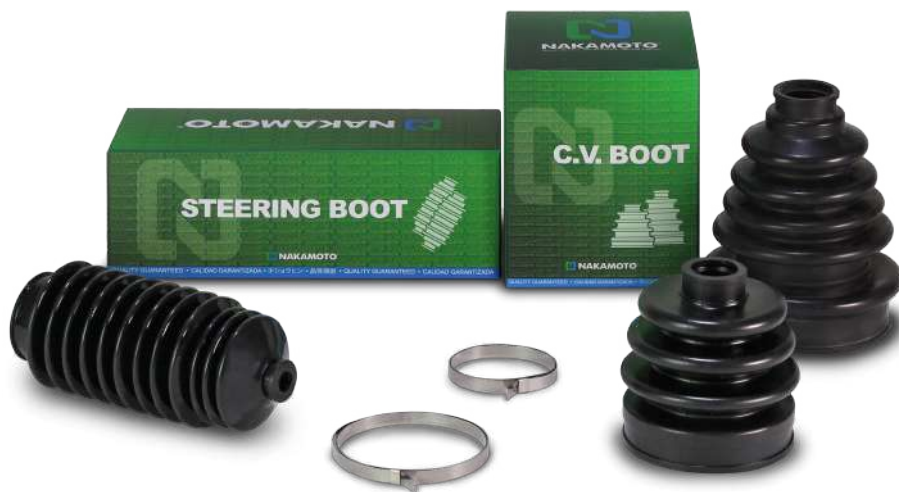
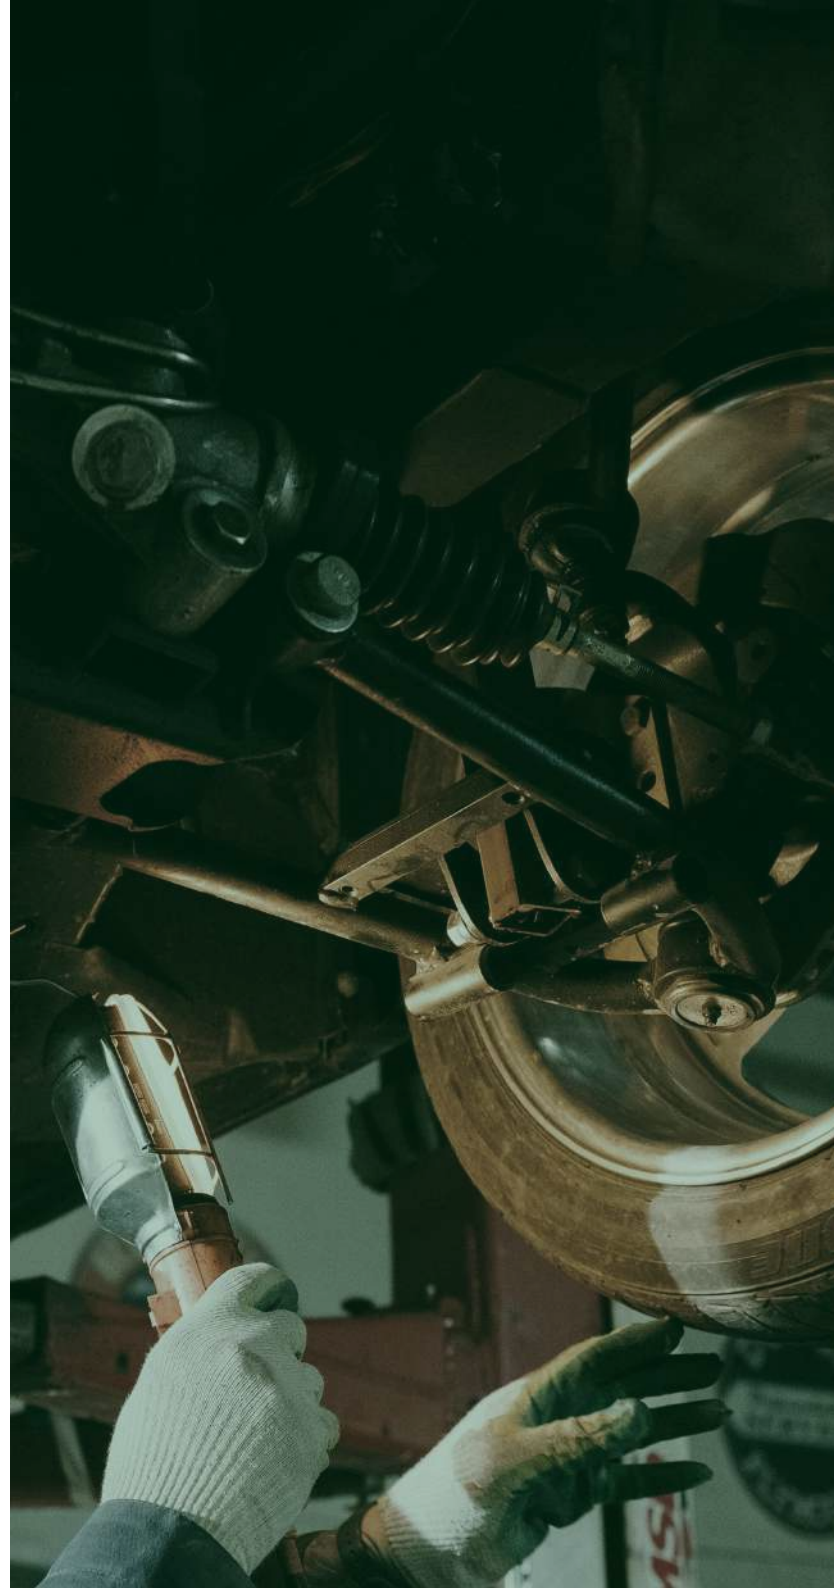
Nakamoto's reinforced boot design is proven to prevent premature cracks. Perfect fitment helps keeps the bearings well lubricated. Easy installation and trouble-free down the road.

Exclusively made with premium CR or NBR rubber to offer adaptability in all working conditions. Tested to last from -40°C to up to 135°C. Maximizing durability and prolong service life!

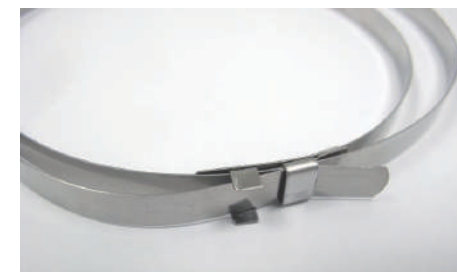
Before

#Specimen no.	After 48 hr
NAKAMOTO C.V. BOOT CLAMP	There was red rust on the sample surface. (Fig no. 1~8)

Rust free after 48 hours of independent testing. Simulating 2 years of usage under normal driving conditions.

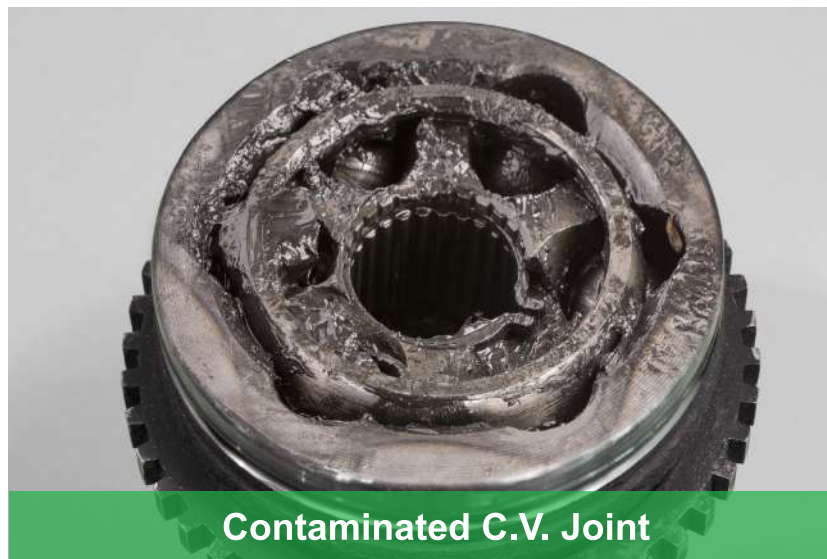
Whether you are just turning the wheel or driving through rough roads, rubber boots are stretched frequently. Overtime, the boot will become brittle and cracks can occur specially in the folding areas. If not replaced quickly, the C.V joint will surely fail due to lack of lubrication or contamination. Choosing a quality rubber boot can prevent expensive repairs!

Contaminated C.V. Joint

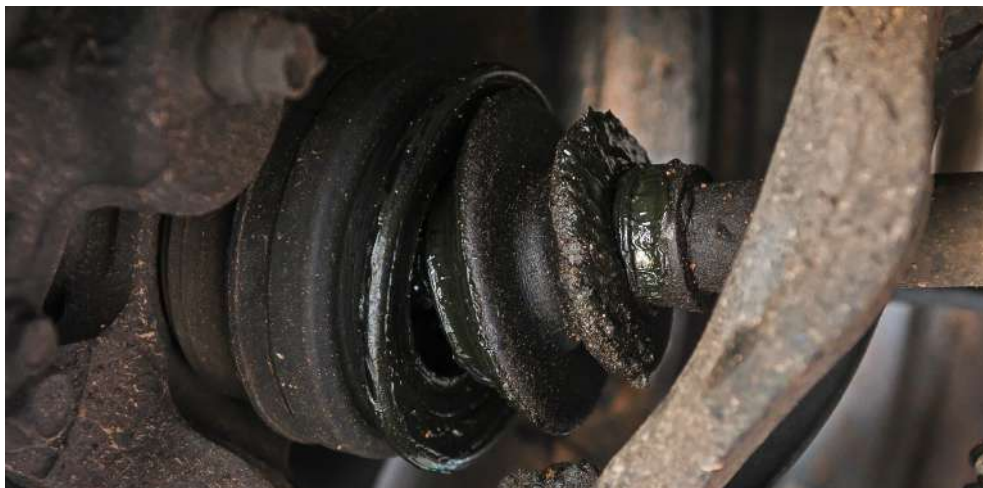
Poor Lubrication

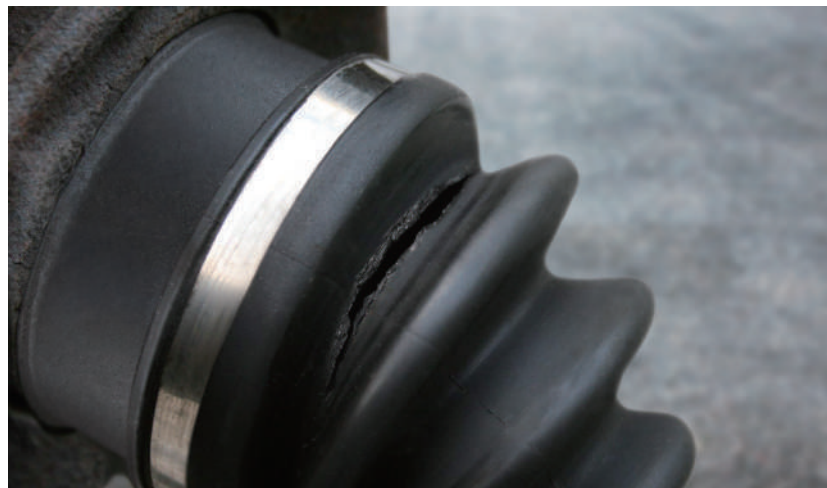
Boot crack is the most common root cause of driveshaft failure.

Cracked C.V. Boot
